# Huston Lake Water Quality Treatment

Consists of a 2-stage treatment design

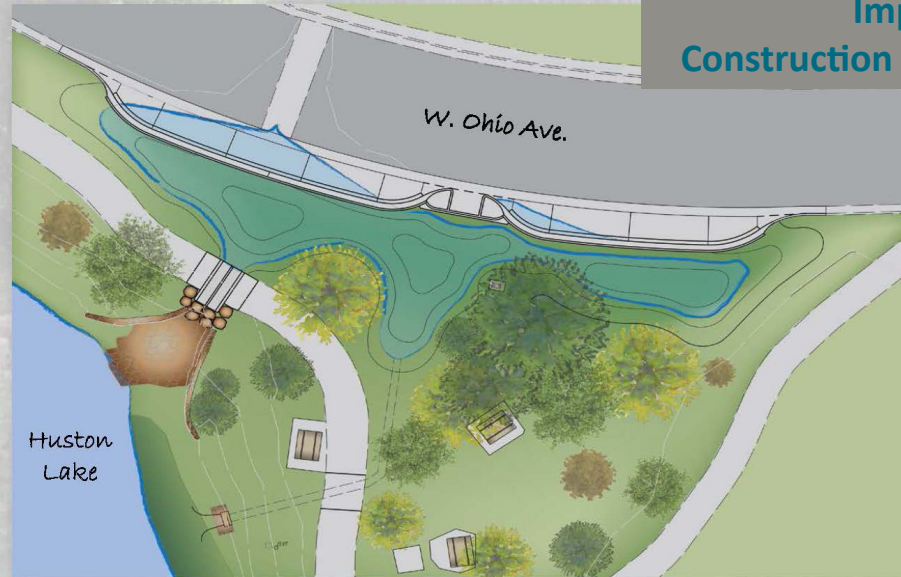
Stage 1 —Concrete forebay intended to retain larger sediment and debris

Stage 2 —Bioretention zone overlaid by turfgrass

- filtration
- infiltration
- biological uptake

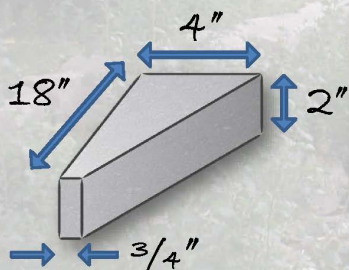
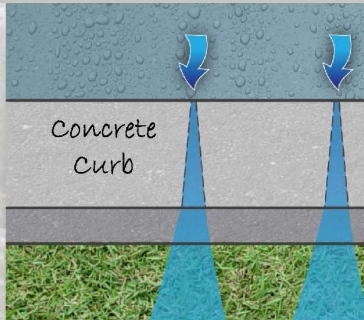
Water is discharged from the forebay through triangular-shaped openings spaced 2-foot O. C. along a curb wall. Openings are sloped.

The City and County of Denver sweeps the forebay once a month from April thru November.

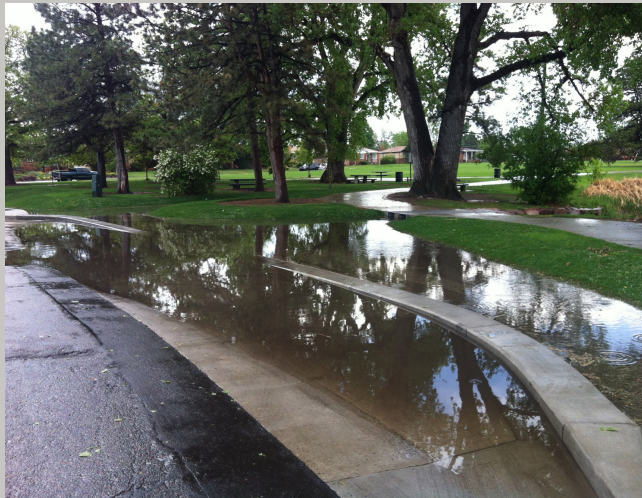
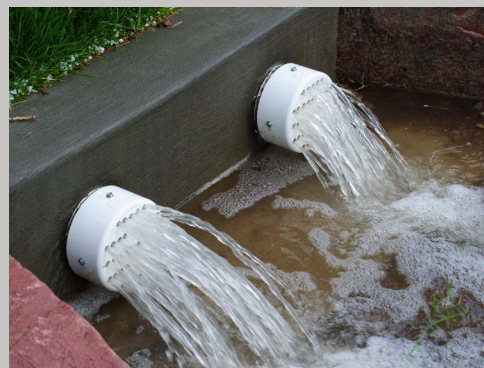
## Post-Construction Observations

- Forebay is removing sediment very effectively. Even when openings appear clogged the forebay does not hold water in between storm events.
- Street sweeping has been effective and removes debris from the openings.
- The bioretention area is not draining as quickly as it did in 2014.
- Vegetation is stressed/dying in the lowest, most heavily loaded portion of the rain garden.
