## 2013 CASFM Stormwater Quality Field Trip

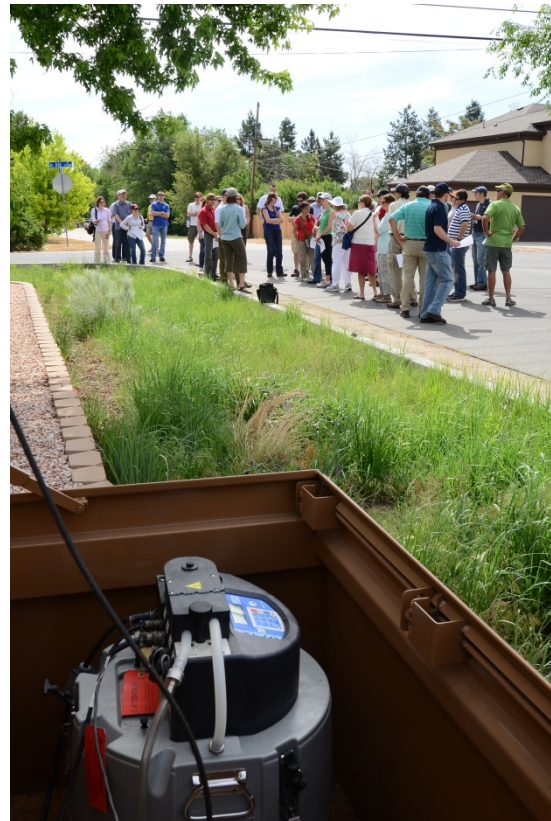
Rain Gardens in Lakewood Right-of Way at 21<sup>st</sup> Avenue and Iris Street (Monitoring equipment shown in the foreground.)

UDFCD partnered with the City of Lakewood and the Urban Watershed Research Institute to construct two rain gardens at this location. The project, completed in April 2011, satisfied multiple objectives including providing stormwater quality treatment, field testing of UDFCD's new rain garden growing media, and fixing a nuisance drainage problem. The rain garden is located within the street right-of-way. UDFCD monitors water quality of the influent and effluent as well as runoff flow and volume. The rain gardens are fully vegetated with the seed mix recommended in the USDCM Volume 3 and assorted plantings.

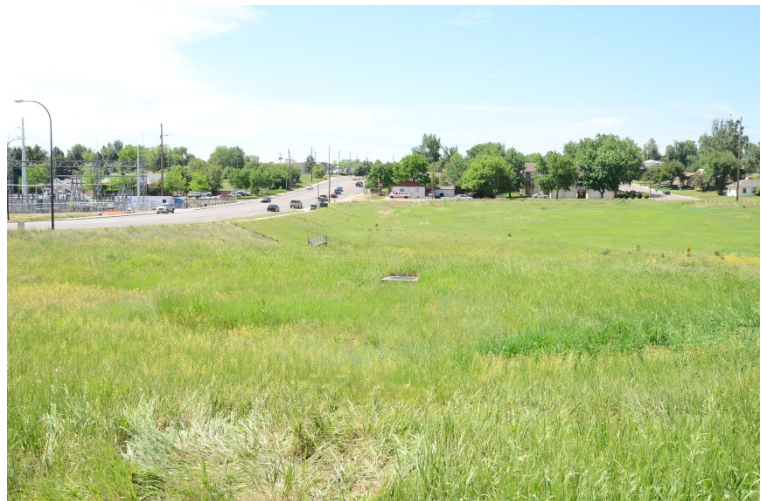
The vegetated sand filter at Belmar Park blends into the landscape leaving the outlet structure as the only recognizable feature of this BMP.

This 10 year old water quality basin was designed per USDCM sand filter criteria, however, a 6-inch top layer of sandy loam was added and the basin was seeded. It treats stormwater from a tributary that's in excess of 6 areas. The City reports that maintenance to date has consisted of debris removal.

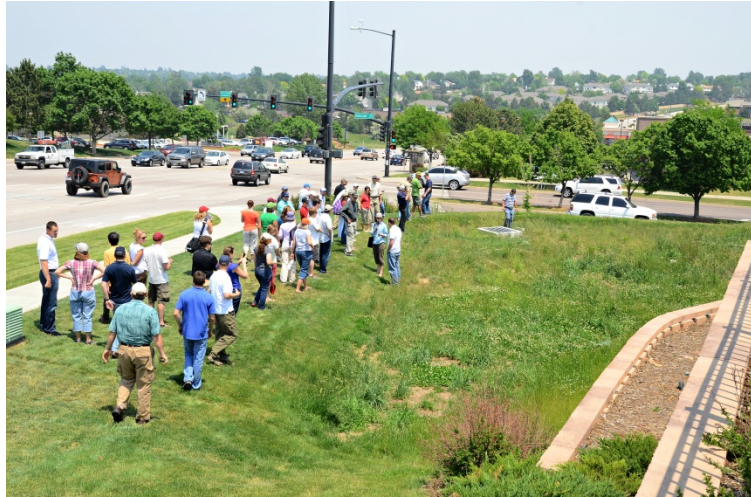
Rain garden at the entrance to the Douglas County Sheriffs' Substation

This site includes a sand filter and two rain gardens constructed with different media. A combination of sand and peat was used as well as the current USDCM – Volume 3 media—a combination of compost having a high shredded paper content and sand.

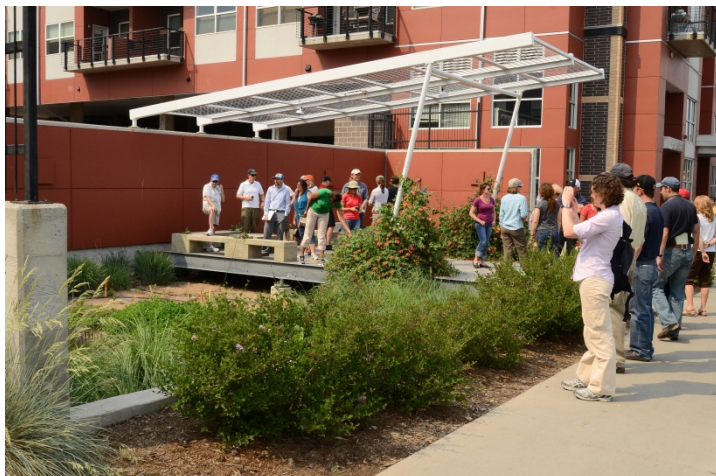
Rain garden at Highland Bridge Lofts

Another rain garden in an urban setting—with a deck bisecting the garden, this design is a great example of making the facility an amenity.

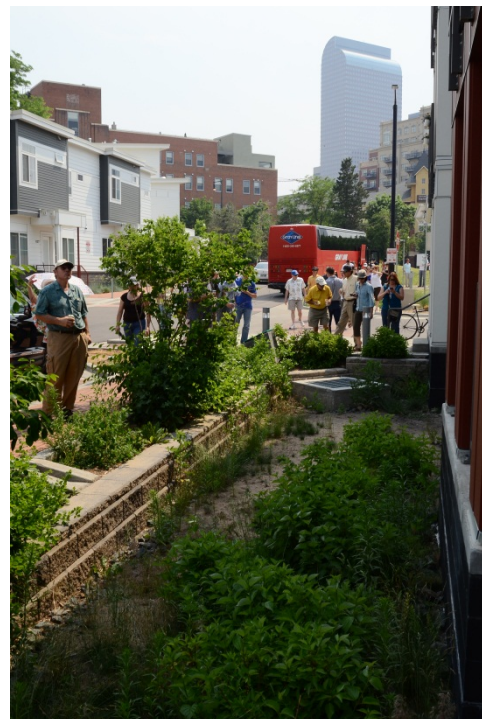
Rain Garden at the Park Ave. DHA site

This Denver Housing Authority (DHA) project included rain gardens in an urban setting.
