CASFM STORMWATER QUALITY FIELD TRIP 2012 BARNUM PARK CONSTRUCTED WETLANDS

by WHPacific, Inc. and The Restoration Group, Inc.

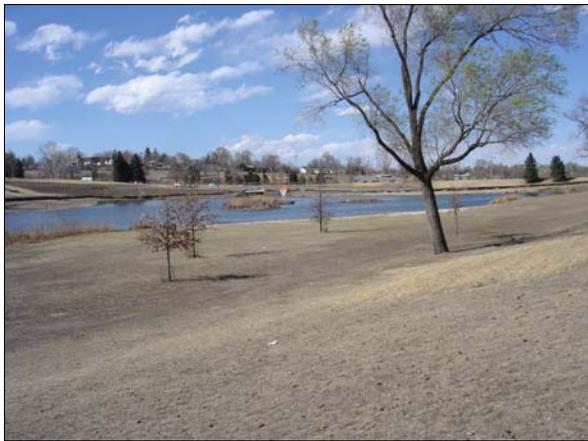
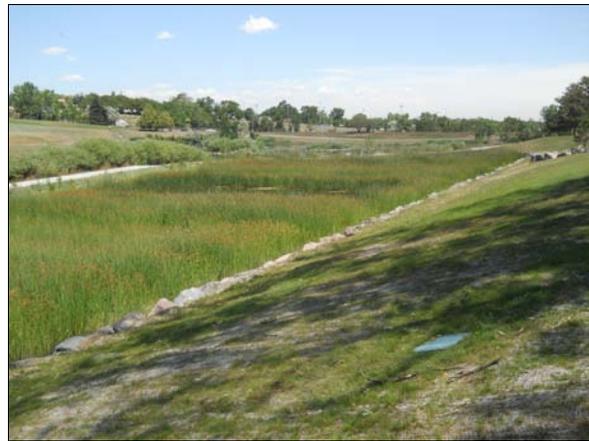
The City and County of Denver and the Colorado Department of Transportation (CDOT) are constructing improvements to Federal Boulevard between Alameda Avenue and 5th Avenue. The improvements include a new storm sewer system that culminates with a 54-inch storm sewer outfall in Barnum Park. In order to protect the lake and provide water quality enhancement for discharges from the storm sewer, Denver Parks and Wastewater Departments contracted with WHPacific and The Restoration Group to design a constructed wetlands basin to treat stormwater runoff from Federal Boulevard prior to discharge to Barnum Lake. These two companies previously teamed to design passive treatment wetlands in Commons Park (Denver) for filtering road runoff prior to discharge into the South Platte River and a wetlands area for Ketring Lake (South Suburban Park and Recreation District) to actively filter nutrient rich waters in a large offstream pond.

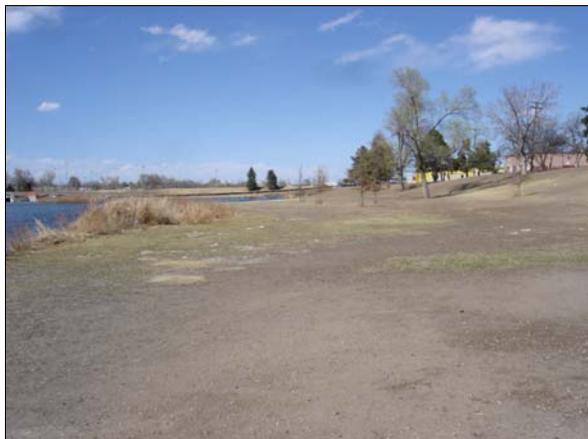
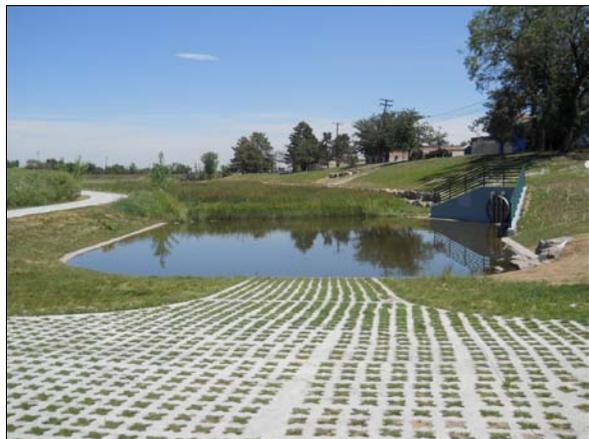
The constructed wetlands in Barnum Park serve a drainage area of 40 acres and provide 1.06 AF of water quality storage and 0.65 acres of wetlands and shallow pool areas where “first flush” runoff discharges are captured, treated, and released over a 24 hour period. The wetlands basin has a concrete-lined forebay accessed by a reinforced concrete grassed pavement maintenance road designed to support the City’s maintenance vehicles, which include a 66,000 lb Vac truck.

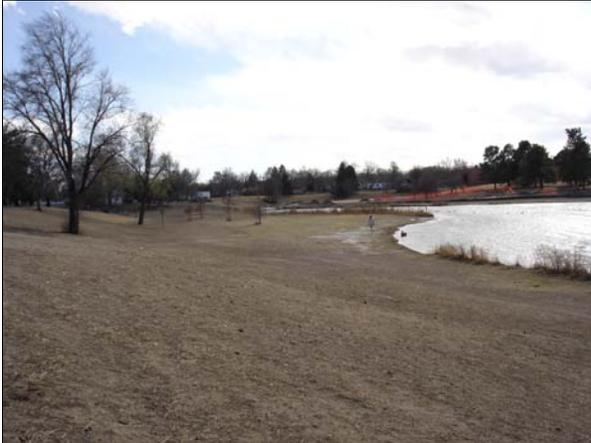
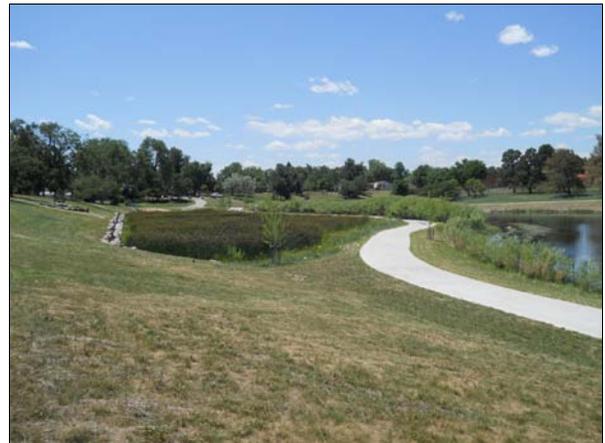
The vegetation selected for the treatment wetlands is dominated by three species which should tolerate elevated salinities expected with street runoff. After filling and then drawing down water in the wetlands area, the wetland plants were installed. For the next 6 weeks the water level was fluctuated to encourage establishment of the wetland vegetation. The site was fenced to exclude water fowl for the first year to reduce plant losses. The shore edge fence on Barnum Lake has been left in place to limit “walk-in” waterfowl access until the newly planted sandbar willows along the lake margin can develop more fully.

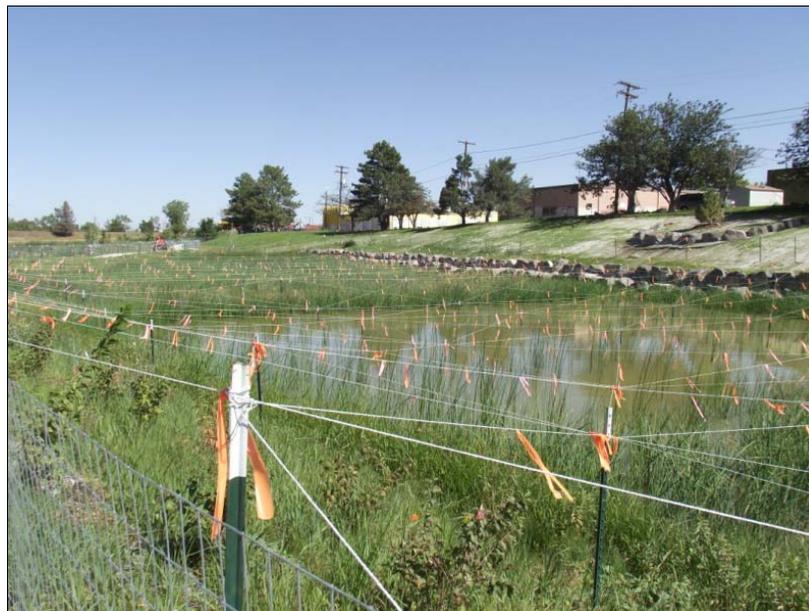
A trail system was installed to permit passive recreational access and reduce trampling of the site. Areas between the wetland and Barnum Lake have been planted with native grasses, wildflowers, trees and shrubs typical of regional riparian areas. The west facing lawn above the wetlands was planted to an alternative drought tolerant turf of fine fescue species.
